HYDRAULIC MODEL STUDIES OF DEER CREEK
DAM SPILLWAY AND OUTLET WORKS
AND A REPORT ON THE OPERATION OF THE
PROTOTYPE TUBE VALVES AND STILLING BASIN
PROVO PROJECT, UTAH

Hydraulic Laboratory Report No. Hyd.-215

NOVEMBER 21, 1946

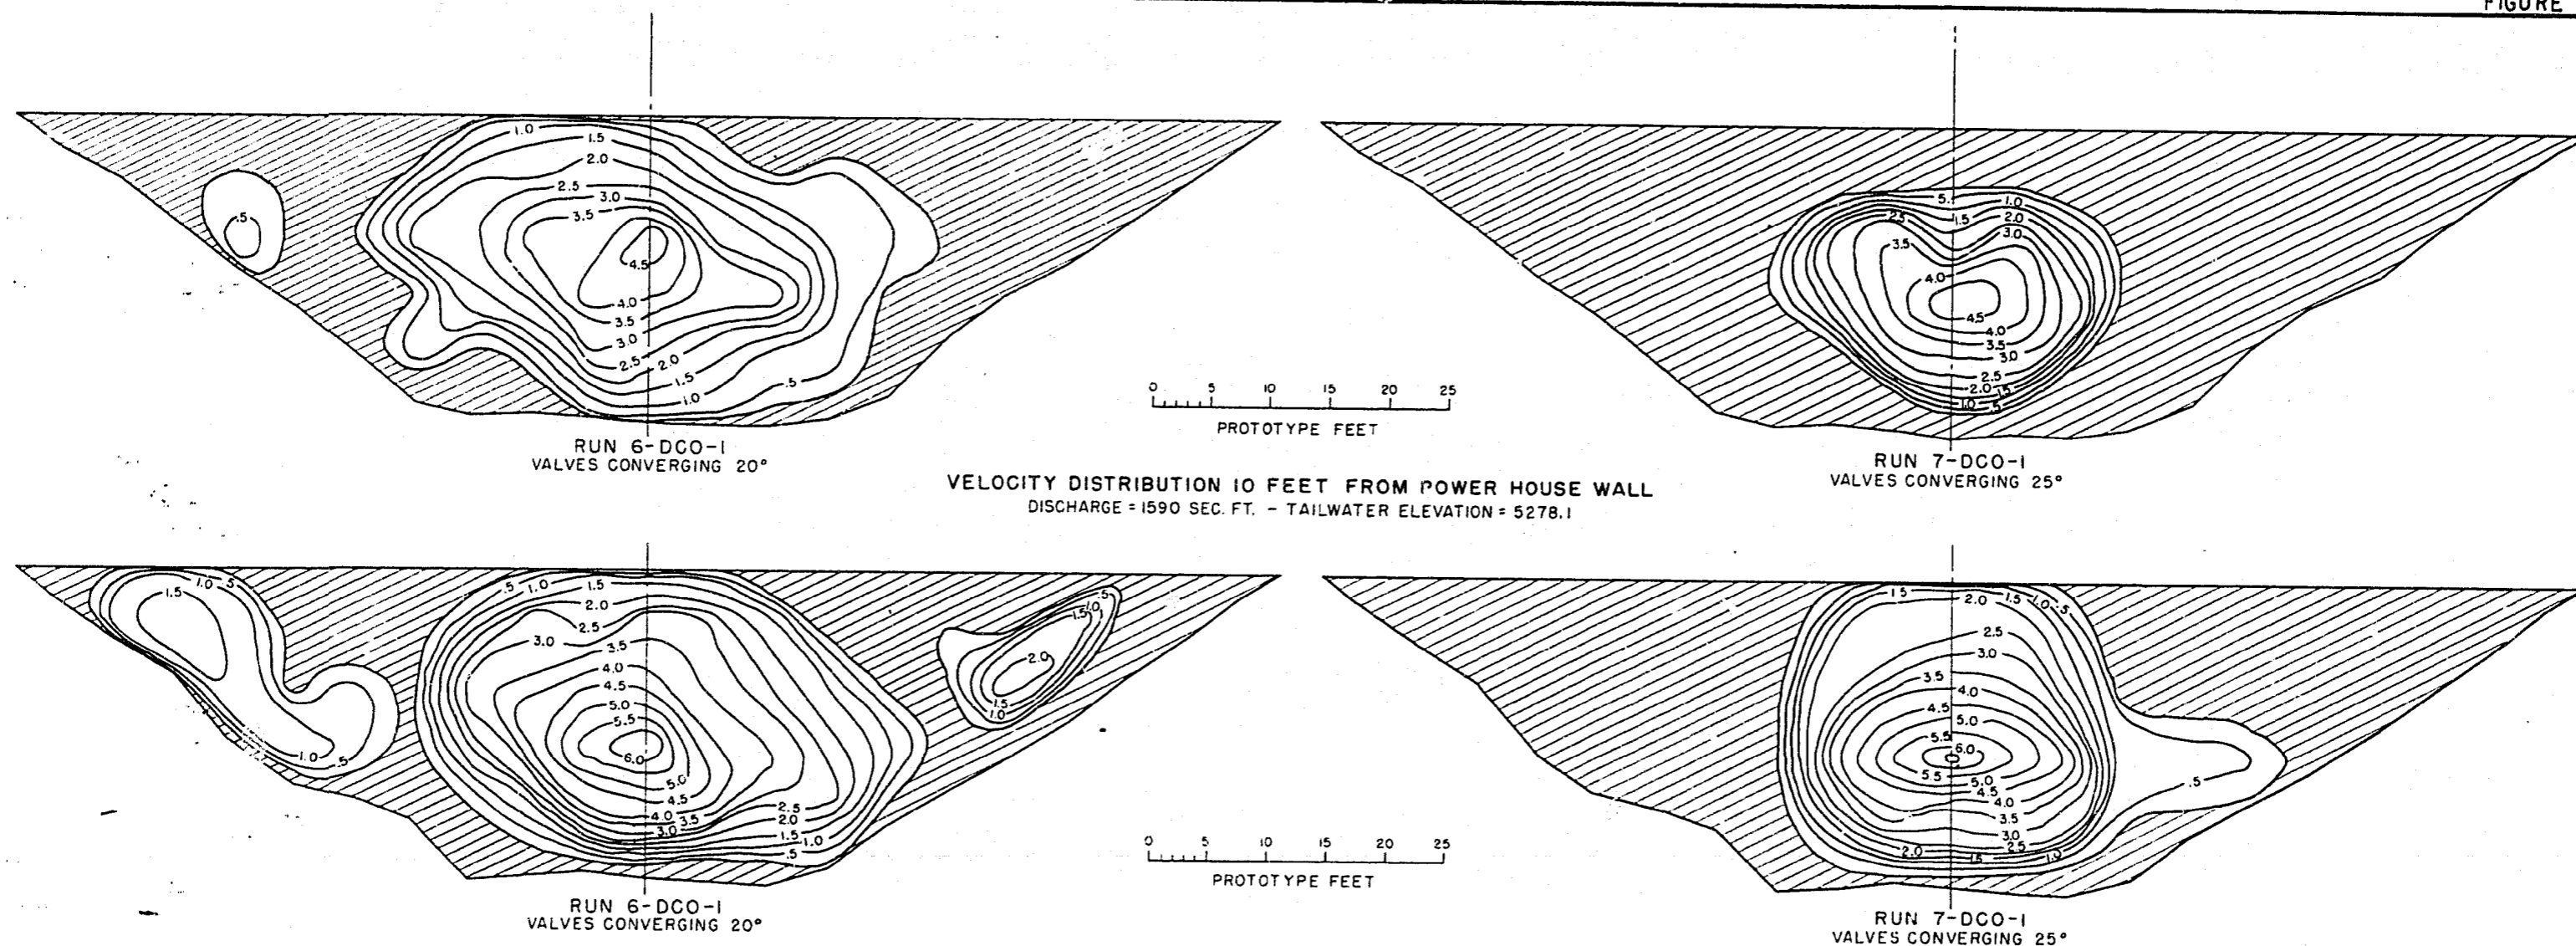
FIGURE 19

NOTES - Velocities shown are in feet per second
in the prototype.
Cross-hatched area denotes forward current
or region of no velocity.
Model scale = 1:20.
Prototype velocity = 4.471 x model velocity.

VELOCITY DISTRIBUTION 25 FEET FROM POWER HOUSE WALL
DISCHARGE = 1590 SEC. FT. - TAILWATER ELEVATION = 5278.1

DEER CREEK DAM
1:20 MODEL STUDIES
NEEDLE VALVE OUTLET WORKS
COMPARISON OF VELOCITY DISTRIBUTION
FOR 20° AND 25° VALVE CONVERGENCE

Velocity direction studies were made on each design, and velocity measurements were taken at prototype distances of 10 feet, 25 feet, and 190 feet from the valve house for the last two tests made on Pool Design No. 2.

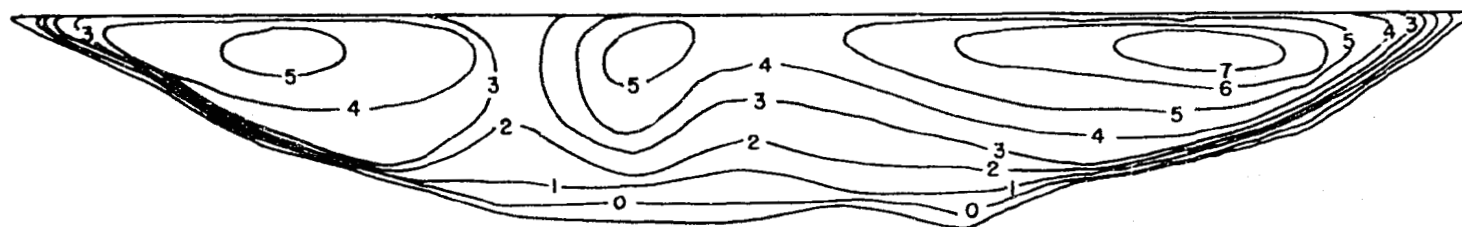
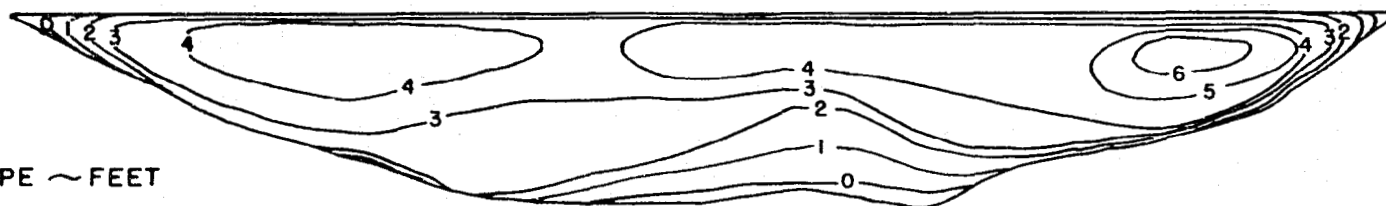
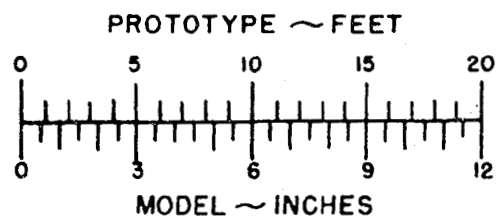
RUN 7-DCO-1
DISCHARGE 1590 SEC. FT.
TAILWATER ELEVATION = 5278.1

RUN 7-DCO-4
DISCHARGE 1200 SEC. FT.
TAILWATER ELEVATION = 5277.3

NOTES:- Velocities shown are in feet per second
in the prototype.
Model scale = 1:20.
Prototype velocity = 4.471 x model velocity.
All velocities are forward velocities.

DEER CREEK DAM MODEL STUDIES
NEEDLE VALVE OUTLET WORKS
COMPARISON OF VELOCITY DISTRIBUTION
FOR MAXIMUM AND DESIGNED DISCHARGES,
MEASURED AT STA. 18+85.0

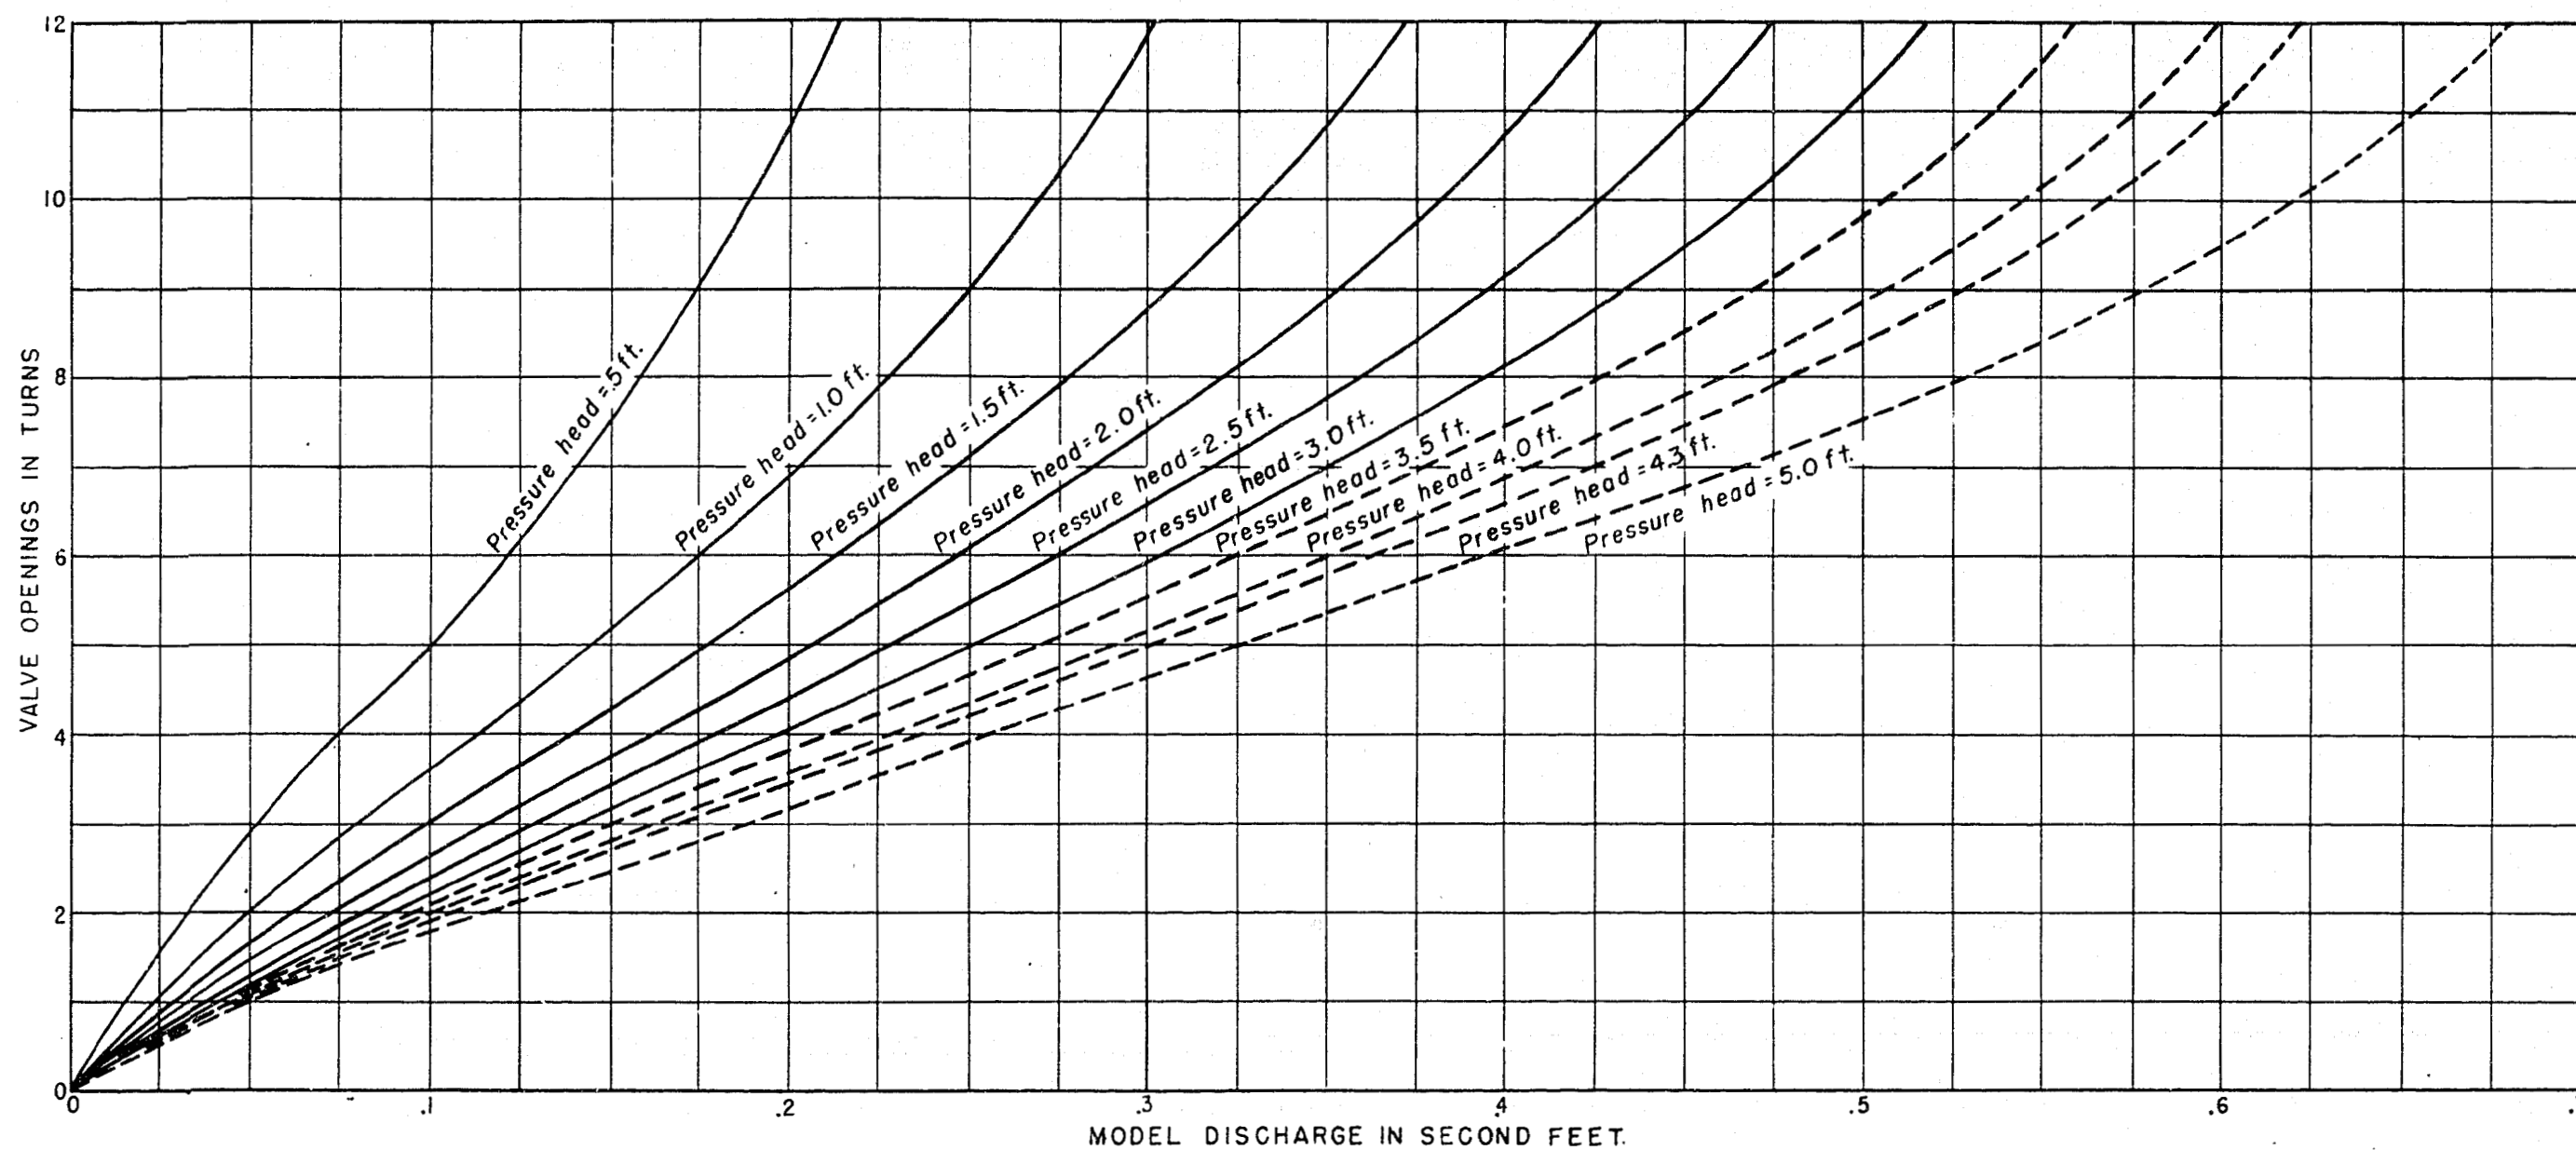
FIGURE 22

TAKEN FROM TESTS FOR KERN COUNTY CANAL OUTLET
WORKS - FRIANT DAM. TESTS SERIES 4-FD TO 9-FD
INCLUSIVE.

DEER CREEK DAM
DISCHARGE OF 2.8" NEEDLE VALVES WITH
VARIOUS OPENINGS AND UNDER
VARIOUS HEADS

Piezometers, located at the upstream ends of the valves, were used to determine pressure heads. The discharge was measured by 4- and 6-inch Venturi meters located between the supply pump and manifold. The valve openings required for each discharge and head combination were determined from curves based on data which had been obtained from a previous calibration.

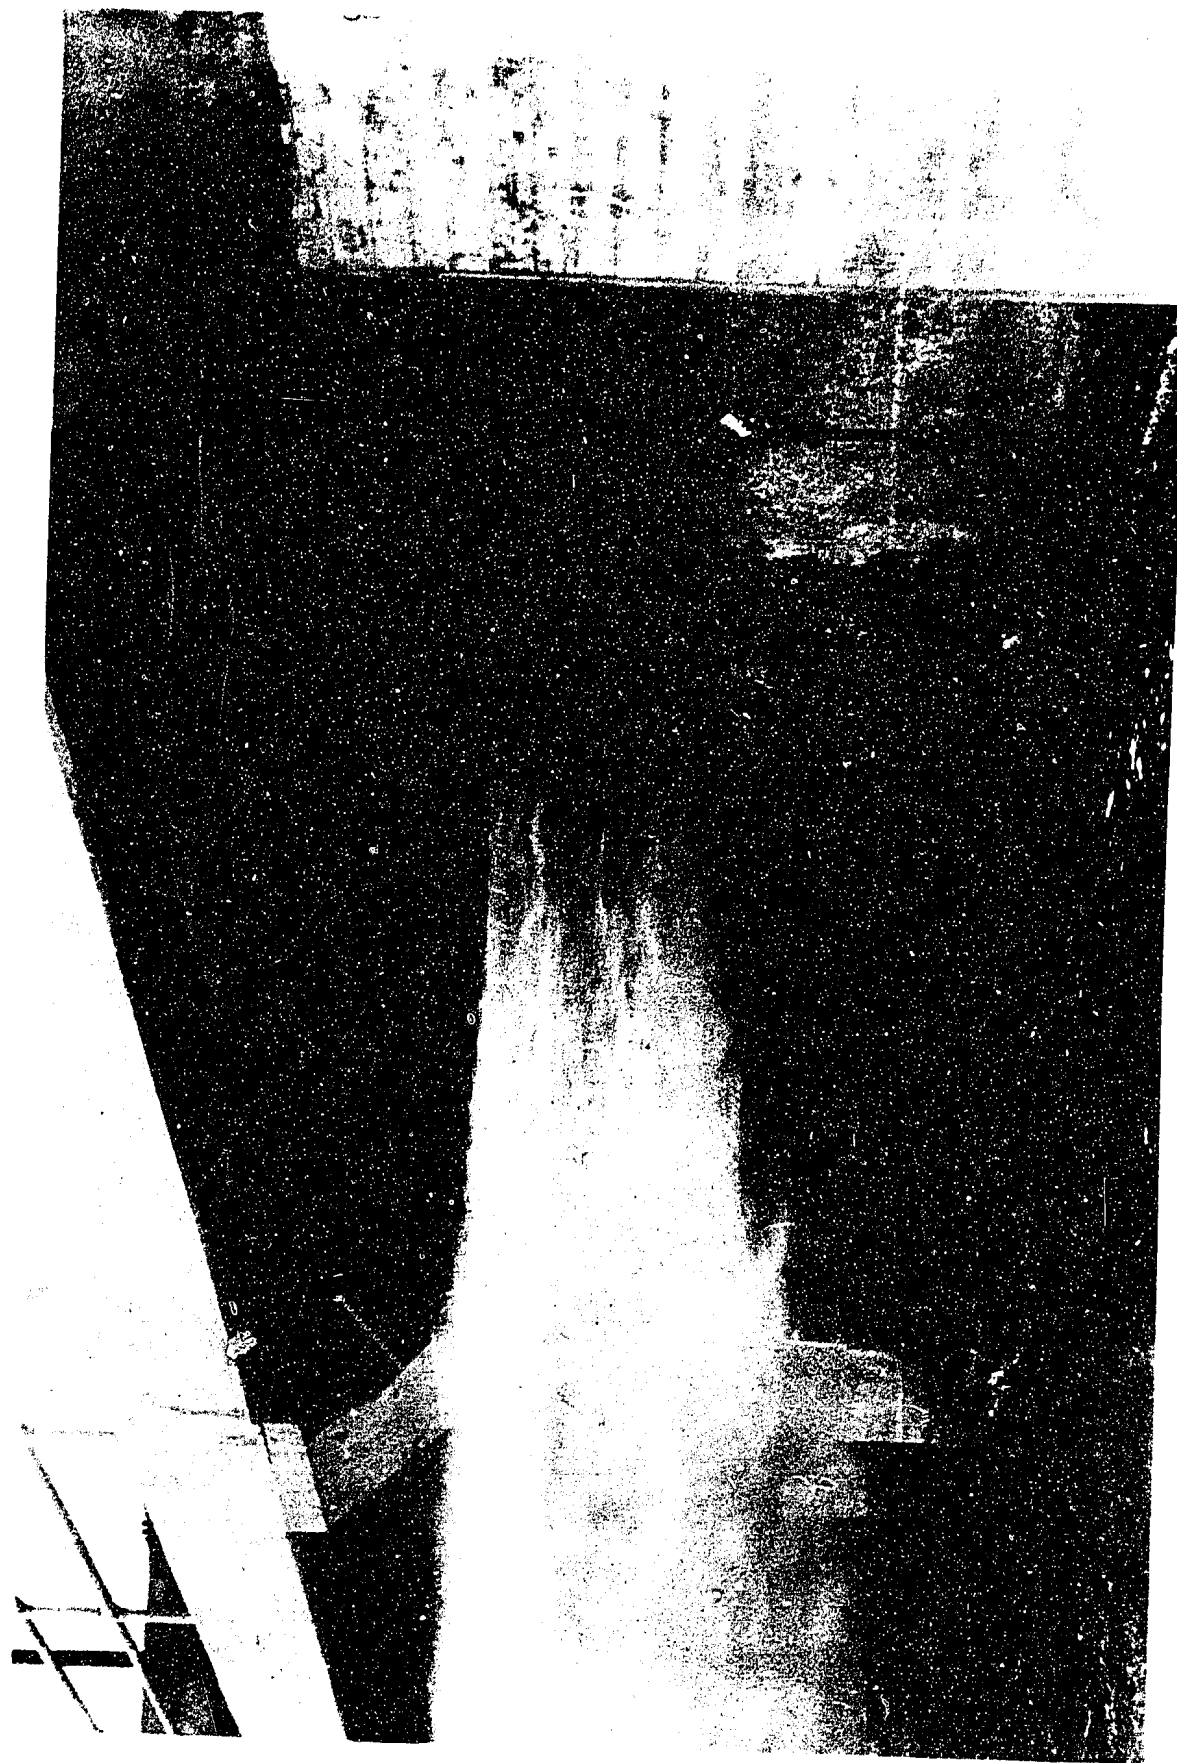
Figure 23

Closure of No. 1 tube valve discharging approximately 500 second-feet.

Figures 23 to 26 illustrate the operation of the tube valves and the stilling-basin.

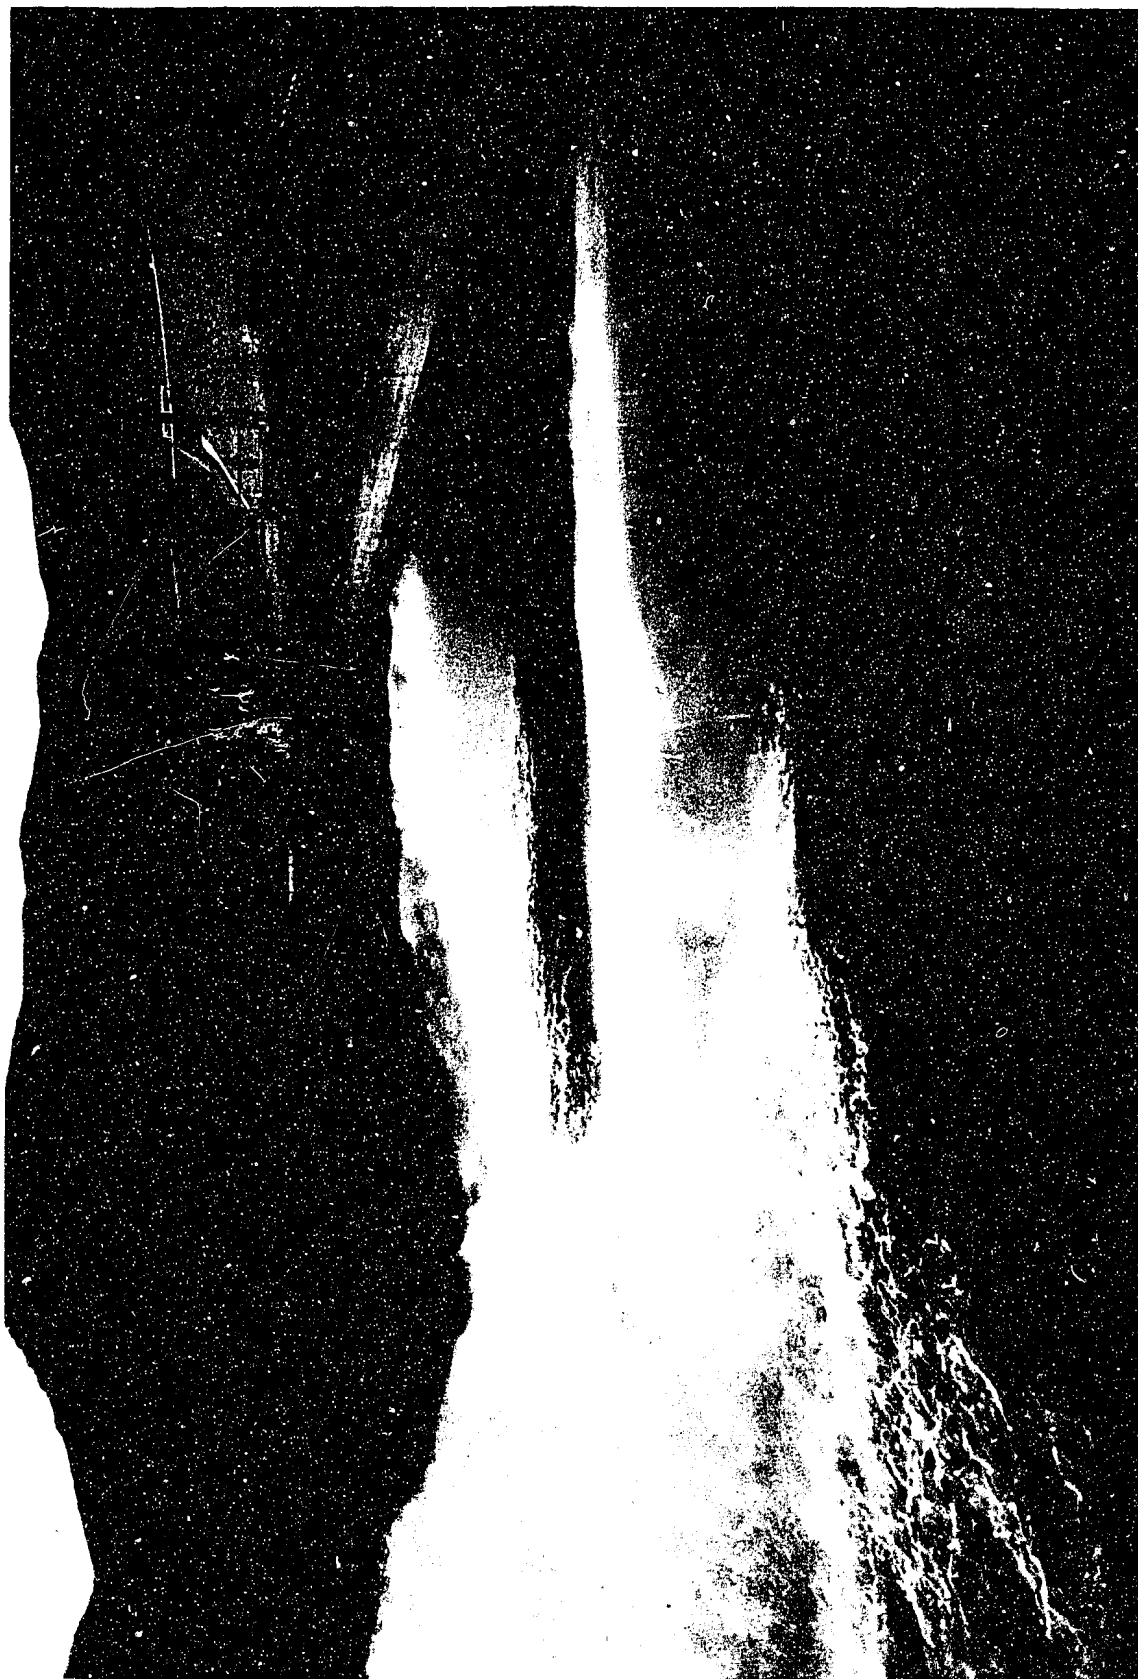
Looking north across stilling-basin; tube valve in foreground discharging 700 second-feet; valve in background discharging 50 second-feet.

"The operation of the outlet works stilling-basin has proved to be very satisfactory. Under all conditions of operation the major part of turbulence of the water was found to occur in the stilling-basin, and the turbulence occurring in the channel which leads from the stilling-basin to the river was not considered to be excessive. It has been found from past operations that the operation of one tube valve at high rate of discharge causes a circular swirling motion of the downstream portion of the stilling-basin. Whenever possible all discharge into the stilling-basin is divided equally through the two tube valves.
